Genuine Ace

### Replacement of Magnetron " S " Band Radar JRC

<b>Make</b>	JRC
<b>Model</b>	JMA-9132-SA
<b>Part Type</b>	M1555
<b>Part Code</b>	5VMAAA00104

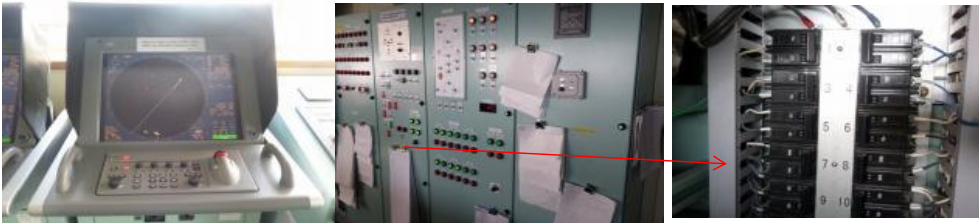
- 1) Before Starting - Switch off Radar No.1 On the Unit (PIC no 1) and Put No. 2 Radar on "Stby"  
Ensure both Scanners are stopped.  
In Chart Table on panel "AC EN 100V Dist Panel" Switch Off No 7 - Radar No.1 power Supply.  
Put Palacards " Men at Work" on Radar No. 1 & 2 and on ships Whistle

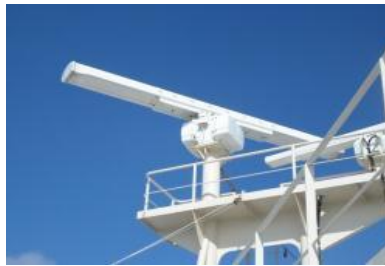
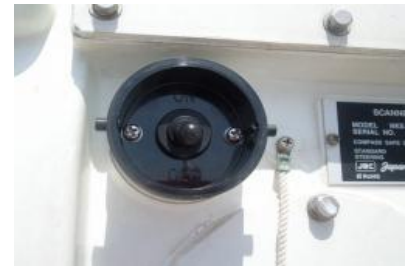
- 2) Working Aloft SWCL-003 is required for this Job
- 3) Before starting part replacement work, turn off the Safety Switch of the scanner unit.

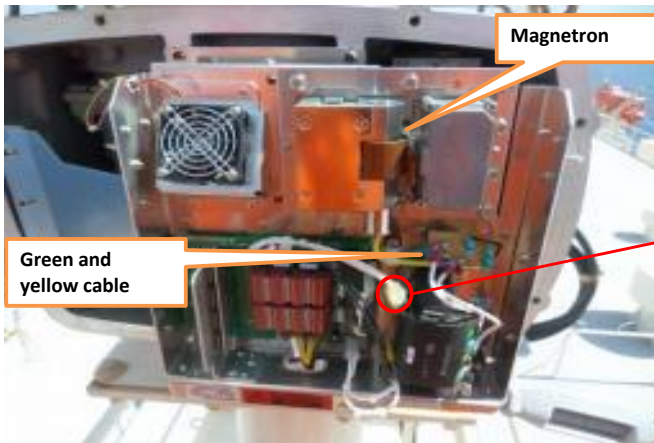
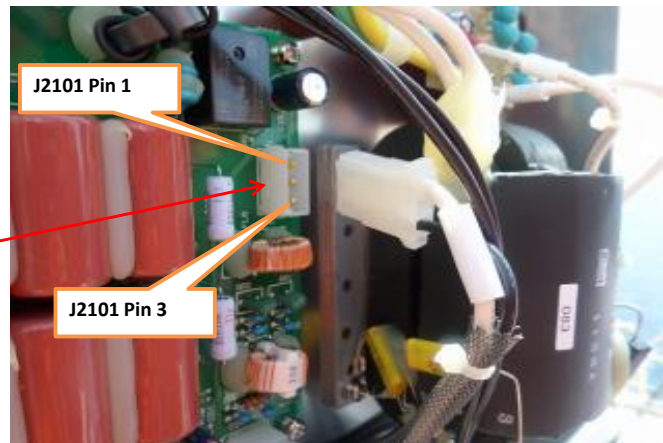
- 4) Remove the pedestal cover

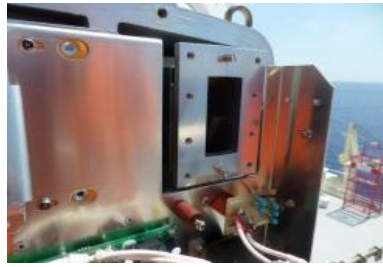
- 7) Remove the Eight screws (M6) to remove the fixture holding the magnetron.  
The screws cannot be removed from the fixture, so loosen the eight screws and remove the magnetron together with fixture.

The Magnetron is held by a hook, but careful not to let it fall  
Use a Non - Magnetic screw driver. If the magnetron comes in contact with any Metal(Tool), Its performance may deteriorate.

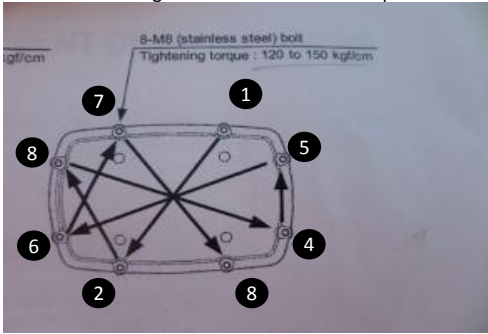
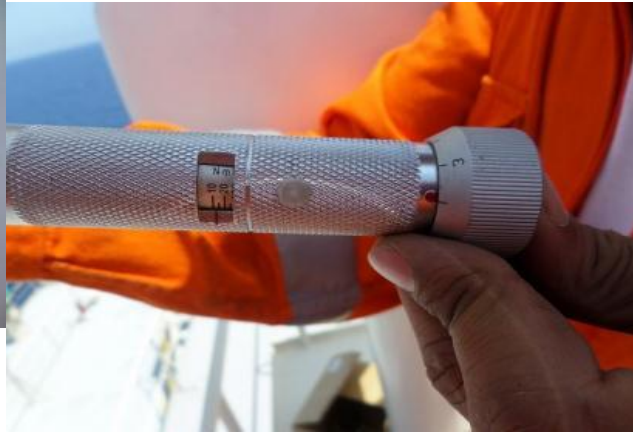
- 8) Install the new magnetron and tighten the screws to hold the cables.  
9) Put back the pedestal cover. Ensure there is no foreign matter or dust adhered to the gasket when you put the cover on. Tighten the screws in below pattern with torque set in screw driver(120 - 150 kgf/cm).
