# Service News

## Prevention of F.O. Solenoid Valve Installation Mistake

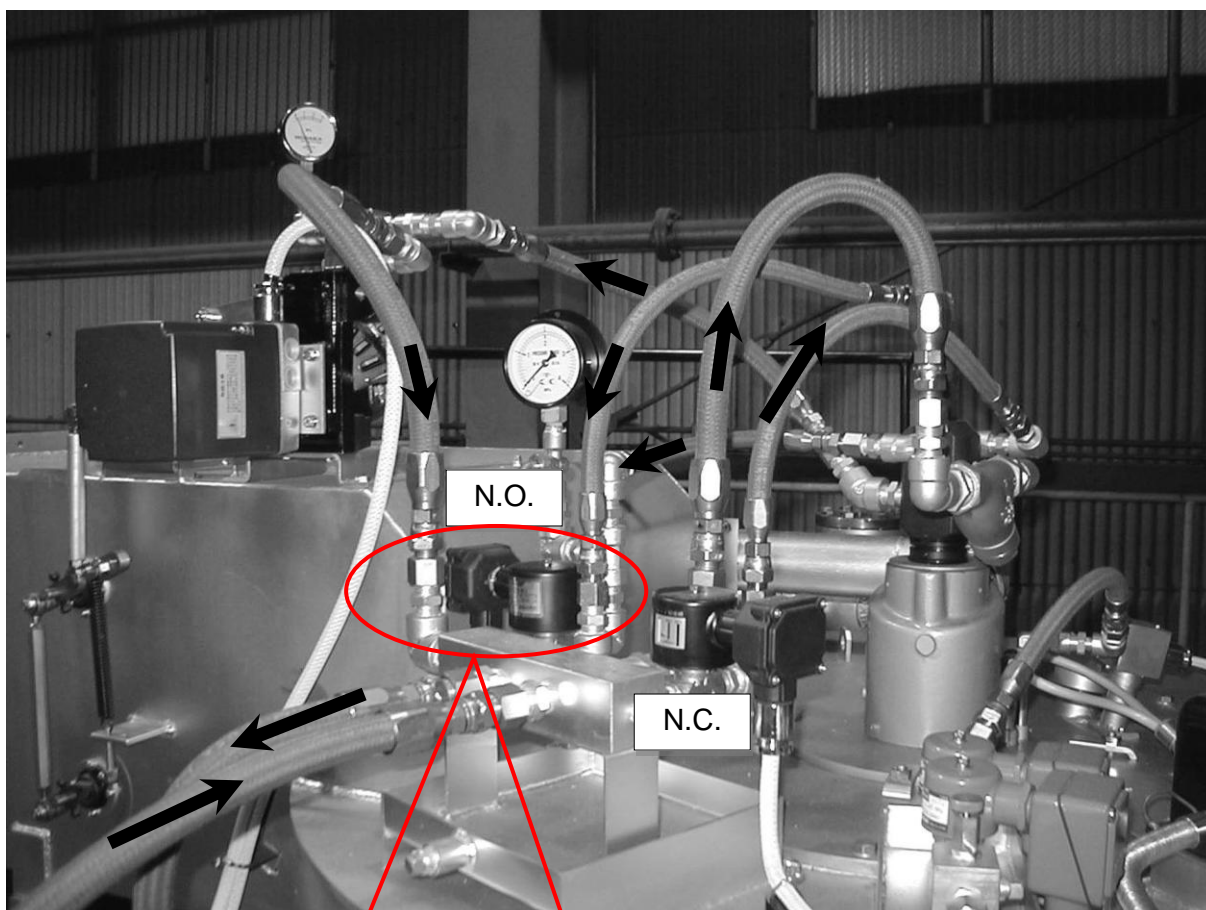
As prevention of these trouble, body of Normally Open (N.O.) is painted **Red** to distinguish Normally Open (N.O.) and Normally Close (N.C.) on valve side.

**Solenoid valve of Normally Open (N.O.) is painted red.**

We would like you to order spare parts with new parts code.

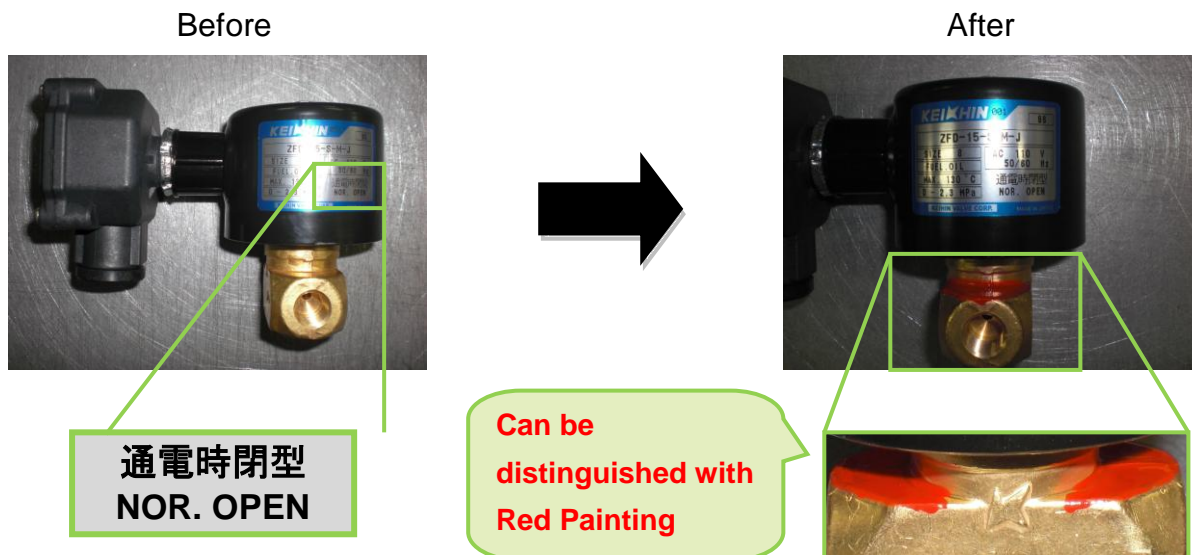
Solenoid Valve Type	Old Parts Code	New Parts Code	Power Supply
ZFD-15-S-M-J	0000-000-H853-0	0000-AKD-0613-0	AC110V
	0000-AA7-0704-0	0000-AKD-0614-0	AC220V

※Solenoid Valve (Type;ZFD-15-H-J) of Normally Close (N.C.) has no change.
